# **Failure of Morphology of (0°)<sub>8</sub> Graphite/Epoxy as Influenced by Environments and Processing**

August 1981

Linda L. Clements, Advanced Research and Applications Corporation, Sunnyvale, California  
Michale J. Adamson, Ames Research Center, Moffett Field, California

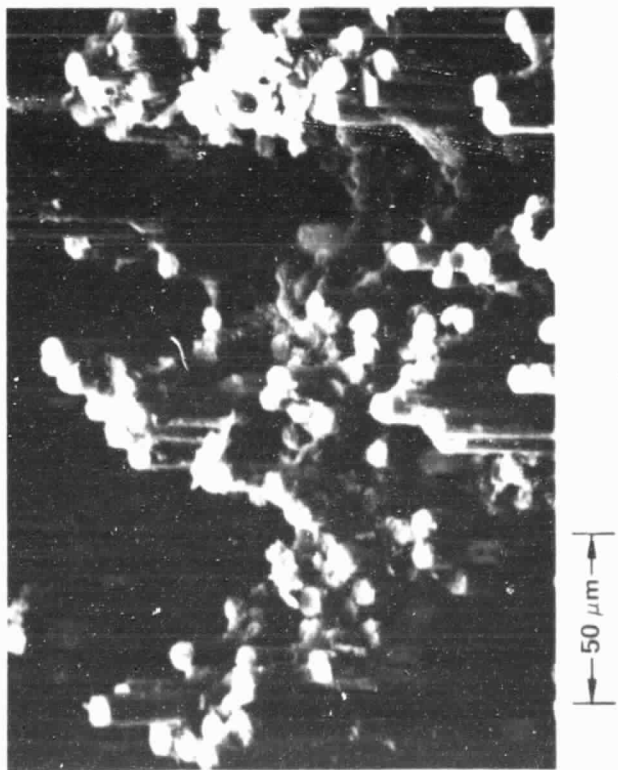
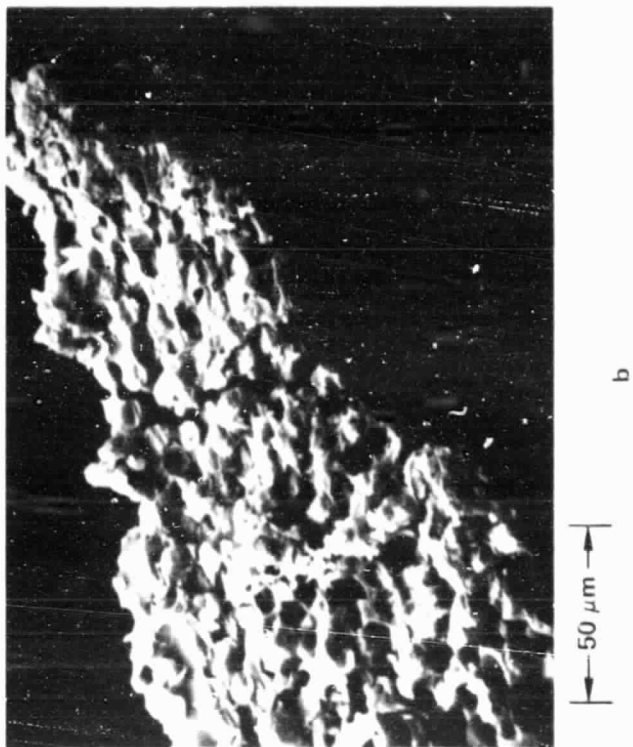
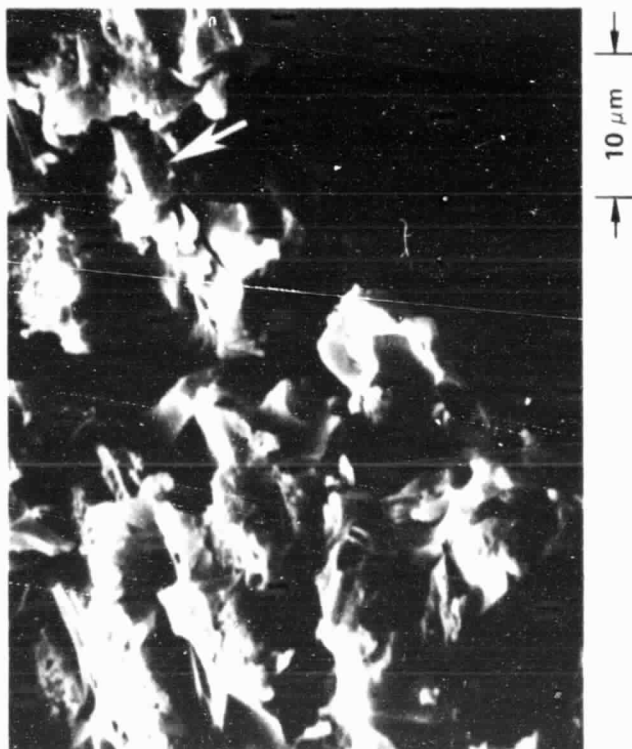
Figure 1.- Scanning electron micrographs comparing failure morphologies resulting from (a) high, and (b) low-energy failure propagation. (c) shows low-energy failure region and "river pattern" (arrow) at higher magnification.

SEM failure-surface examination revealed some general types of failure morphologies resulting from different types of failure propagation modes. Figure 1 illustrates the two most distinctive morphologies. The failure surface in Fig. 1a shows a varied topography with filaments and filament bundles at many different heights. The fracture path in this specimen was quite circuitous, and in fact was probably due not to a single crack but rather to a coalescence of cumulative damage. By analogy with metals, we assume that this morphology resulted from relatively "high energy" failure propagation. On the other hand, the failure surface in Fig. 1b is relatively smooth. As the higher magnification view in Fig. 1c shows, this smoother surface even displays the "river patterns" (striations perpendicular to the moving crack front — see arrow) — due to stopping and starting of a propagating crack — which are typical of more homogenous materials. This topography indicates that the failure crack

went through the material easily, with little secondary damage (such as intersecting secondary cracks) or other hindrance to its direct progress. We assume that this morphology results from relatively "low-energy" failure propagation.

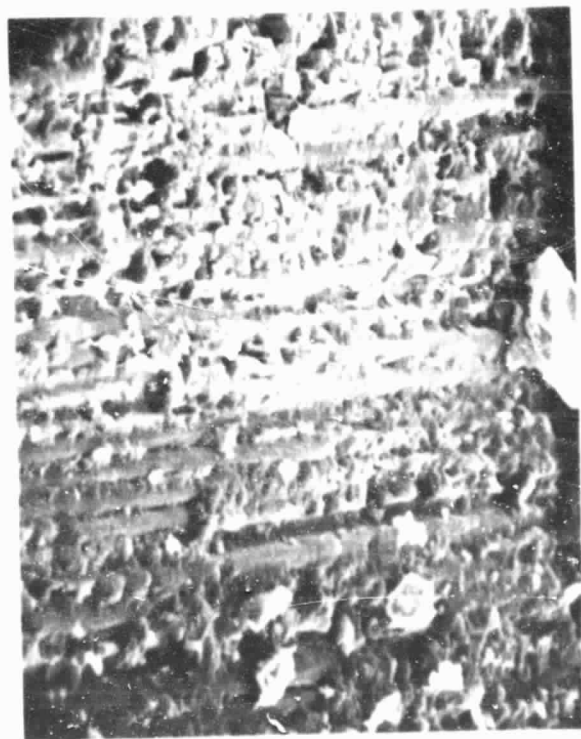
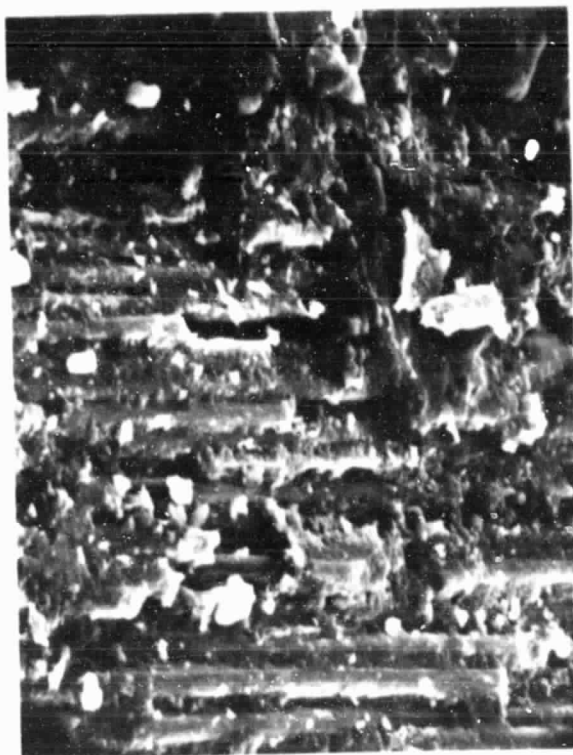
Figure 2.- Scanning electron micrographs comparing appearance of (a) unpolished to (b) polished specimen edges.

edges. Figure 2 compares a typical scanning electron micrograph of a polished edge (Fig. 2a) to one of an unpolished edge (Fig. 2b). While the polished edge has individual damaged filaments, the unpolished edge shows numerous areas where groups of filaments are damaged. An examination of specimen failure mode revealed the apparent effect of these groups of damaged filaments on the failure of unpolished-edge specimens. More than 60% of the specimens with unpolished edges failed by low-energy failure propagation, and the balance failed at the tabs or by splitting and delamination. On the other hand, more than 70% of the specimens with polished edges failed by high energy or mixed modes; few failed by low-energy failure propagation. We conclude that the damaged edges of the unpolished-edge specimens constituted defects which produced the low strengths observed.

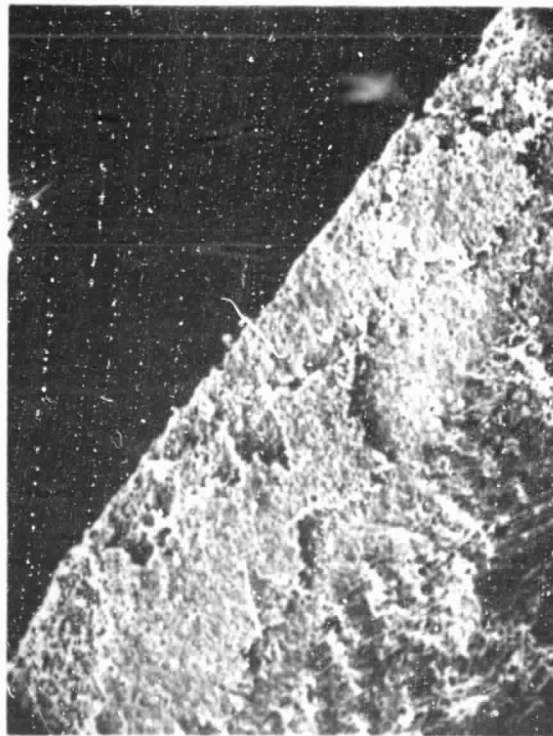
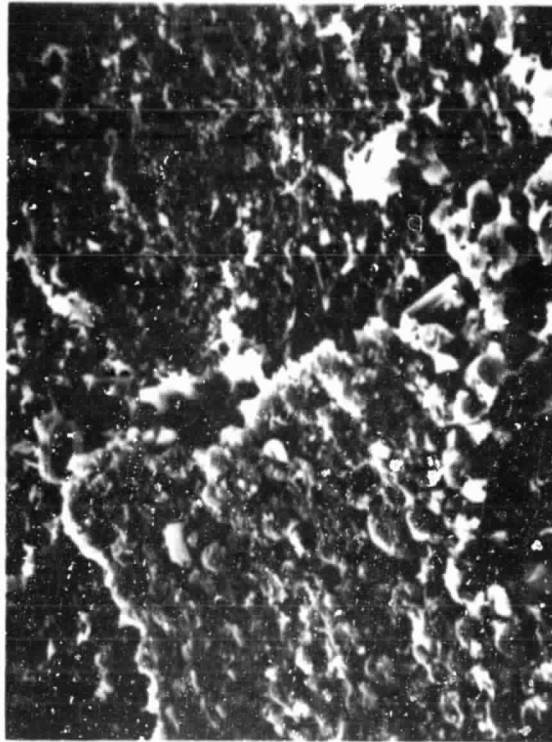
Figure 3.- Scanning electron micrographs showing at two magnifications a low-energy failure region with obvious differences between different fiber bundles in a batch B specimen (tested at 25°C wet).

SEM examination of the failure surfaces of batch B specimens detected differences in the fiber bundles in the specimens. Figure 3 illustrates this difference in a low-energy failure region. Even in such a relatively smooth area individual fiber bundles stand out. In other specimens, the borders between fiber bundles were traced as the location of a 0° split in the composite, and in others a delamination seemed to originate at the border between such bundles. We conclude from these observations that the regions of altered epoxy associated with some of the batch B fiber bundles led to a different failure mode for batch B specimens and to lower strengths at elevated temperature or moisture content. At 25°C dry the differences in failure modes in batches A and B are only slight, thus the strength effect is minimal. (The batch B mean strength is lower than batch A, but the difference is not statistically significant.) The altered epoxy has a more important influence at elevated temperature or moisture content, however, and apparently produces severe degradation when temperature and moisture are combined.

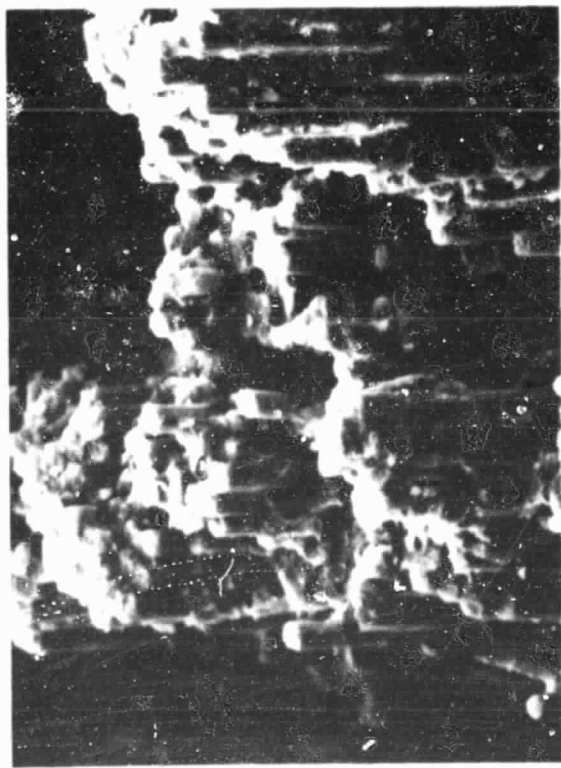
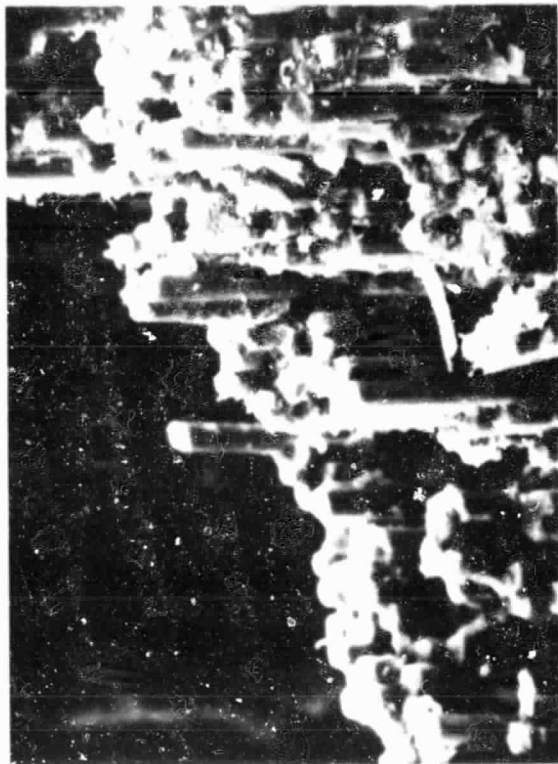
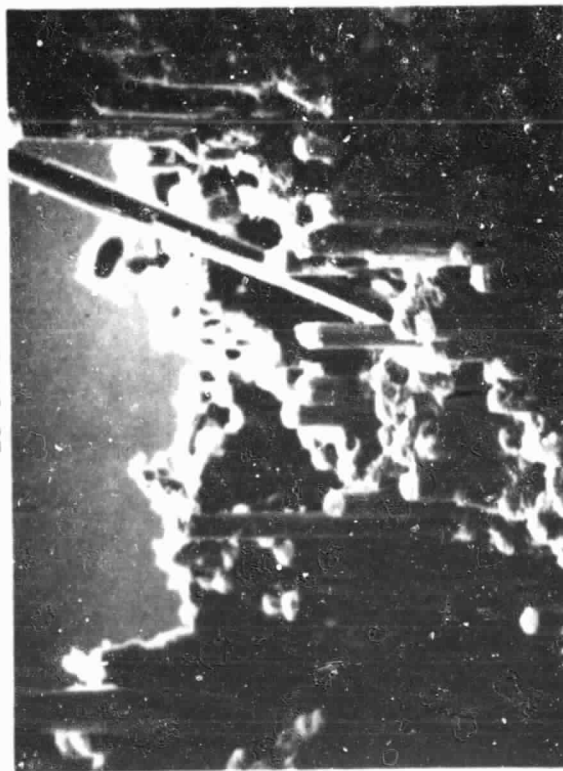
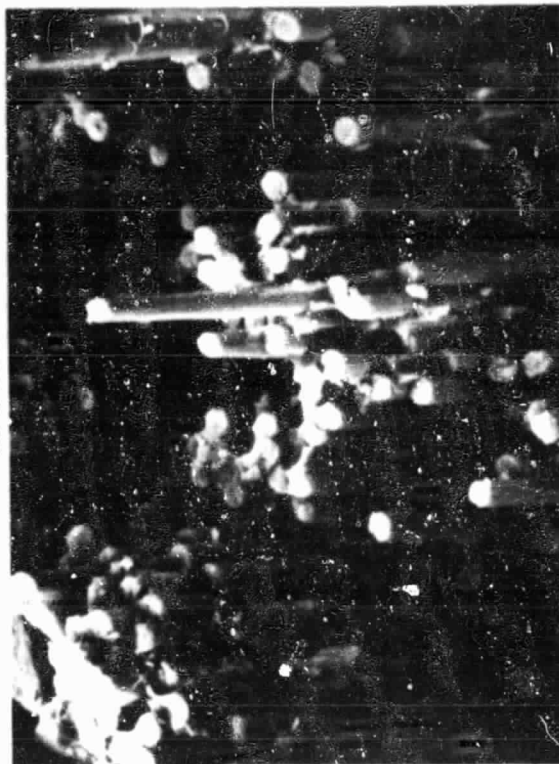
Figure 4.- Representative failure morphologies of unpostcured batch A specimens with polished edges tested at four environmental conditions: (a) 25°C dry, (b) 96°C dry, (c) 25°C wet, and (d) 96°C wet.

Figure 4 shows representative failure morphologies for unpostcured batch A specimens with polished edges at the four environmental conditions considered. It should be noted that while a representative micrograph is given for 96°C wet, early end-tab failures on many of the specimens cast doubt upon all of the strength data at this condition. Thus, Clements and Lee did not report 96°C wet strength in Ref. 1. (The data we show in Tables 1 and 2 are taken from their raw data.)

In examining Fig. 4, it is also important to remember that there was considerable specimen-to-specimen and area-to-area variation in morphology for all conditions. Thus, these micrographs in no way represent the diversity of morphologies encountered at any environmental condition, but rather are typical of the most common or average morphology at that condition.

There is another difference, on the average, between the morphologies at the two conditions, however. At 25°C wet the filaments protruding from the failure surface tend to be cleaner and longer than at 25°C dry. The micrographs of Figs. 4a and 4c illustrate this difference. This observation is consistent with increased interfacial debonding between filament and matrix. Since the longitudinal tensile strength nonetheless increases, either the increased interfacial debonding does not weaken the overall composite, or any weakening is offset by decreased flaw sensitivity.

The influences of temperature and moisture are combined at 96°C wet. As is shown in Fig. 4d, at this condition the failure morphology contains many bare filaments — filaments that are longer and considerably cleaner than those at 25°C wet. Such long clean filaments are often considered to be filament "pull-outs," but, as is seen in Fig. 5a, there are few corresponding pull-out holes. Figure 5b demonstrates the reason for this discrepancy. The epoxy between filaments has not only debonded but has also broken up and fallen away. We thus conclude that the combined influence of temperature and moisture

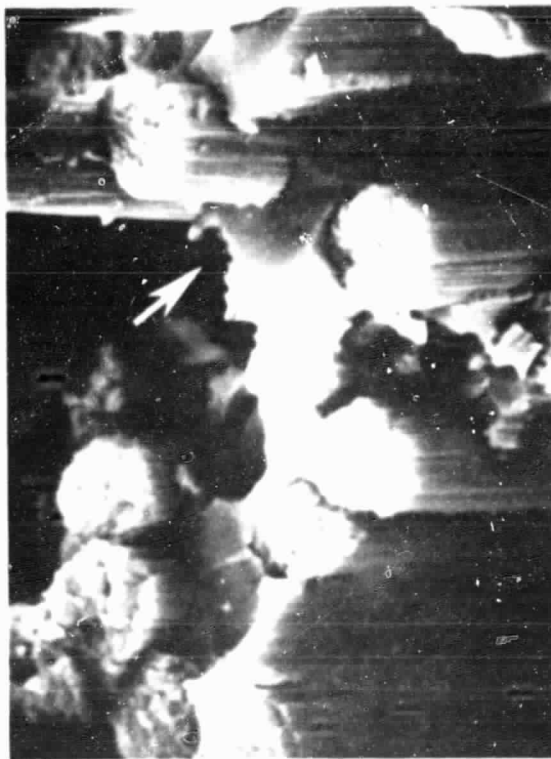
Figure 5.- Scanning electron micrographs of failure surfaces of unpostcured batch A specimens with polished edges tested at 96°C wet. (a) shows long clean filaments but few "pull-out" holes, and (b) shows epoxy that has broken up and is ready to fall away (arrow).

The 96°C wet specimens tested by Clements and Lee actually differed from the 25°C wet specimens in a respect other than temperature. All of their specimens were held at 25°C until shortly before mechanical testing. Adamson [3] has shown that, for temperatures below the conditioning temperature at which moisture was introduced (60°C in this case), the saturation moisture content of graphite/epoxy specimens is inversely proportional to temperature. Thus, as was confirmed by weight-gain studies of Clements and Lee's specimens, their specimens saturated at 60°C picked up yet more water at 25°C. Furthermore, the resulting saturation (or near saturation) moisture content achieved at 25°C is greater than the saturation moisture content at 96°C. Thus, when the temperature of wet specimens held at 25°C was increased, a condition of supersaturation was introduced. Thus, in spite of the essentially 100% humidity of the mechanical test at 96°C wet, desorption would have occurred (and would have continued for several days). During this period of supersaturation, particularly with the aid of the applied tensile stress, covalent bonds may have been broken. Thus, first microcracking and then the type of epoxy cracking shown in Fig. 5b may have resulted.
